# ESP32 Series SoC

## Errata

Version 2.5  
Espressif Systems  
Copyright © 2022

This document details hardware errata and workarounds in the ESP32.

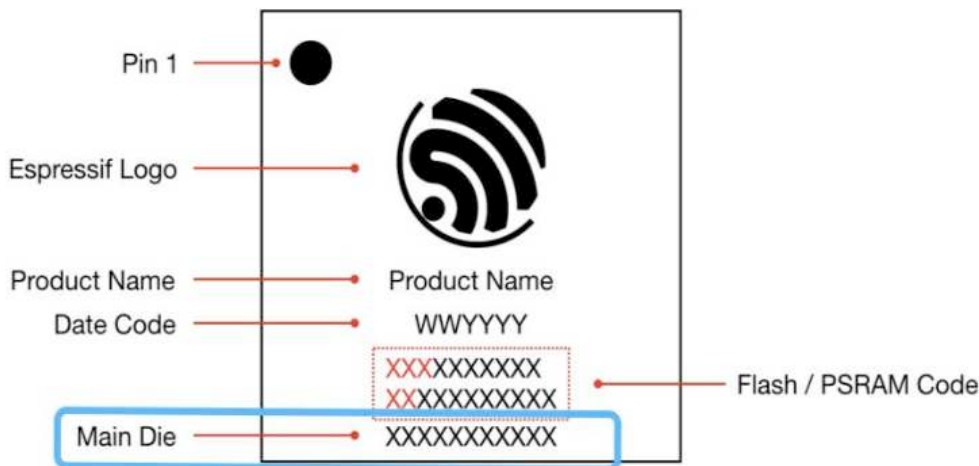
Figure 1-1: Chip Marking Diagram

- Main Die** line in chip marking, see the figure below.

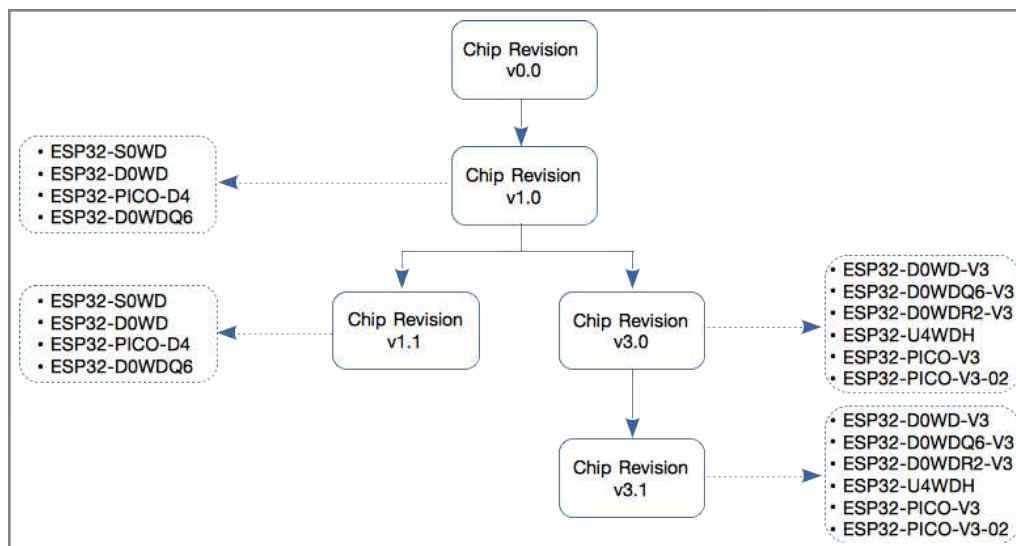
Figure 1-2: Chip Revisions and Chip Variants

The figure below shows the relation between chip revisions and chip variants.

- ESP32-S0WD, ESP32-D0WD, ESP32-PICO-D4, and ESP32-D0WDQ6 will be produced with chip revision v1.1 inside, see [PCN20220901](#).
- ESP32-D0WD-V3, ESP32-D0WDQ6-V3, ESP32-D0WDR2-V3, ESP32-U4WDH, ESP32-PICO-V3, and ESP32-PICO-V3-02 will be produced with chip revision v3.1 inside, see [PCN20220901](#).
